STATE OF CALIFORNIA  
DEPARTMENT OF PUBLIC WORKS  
DIVISION OF WATER RESOURCES

REPORT ON  
PHYSICAL EFFECTS OF  
ARVIN EARTHQUAKE  
OF JULY 21, 1952

August, 1952

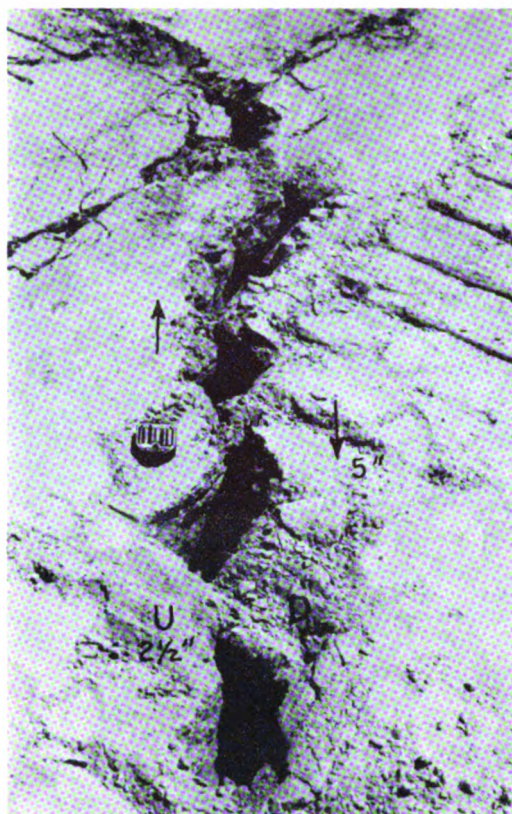
Photo No. 1—A northeast trending crack in a dirt road about 15 miles south of Bakersfield. Movement is as noted. View is looking northeast.

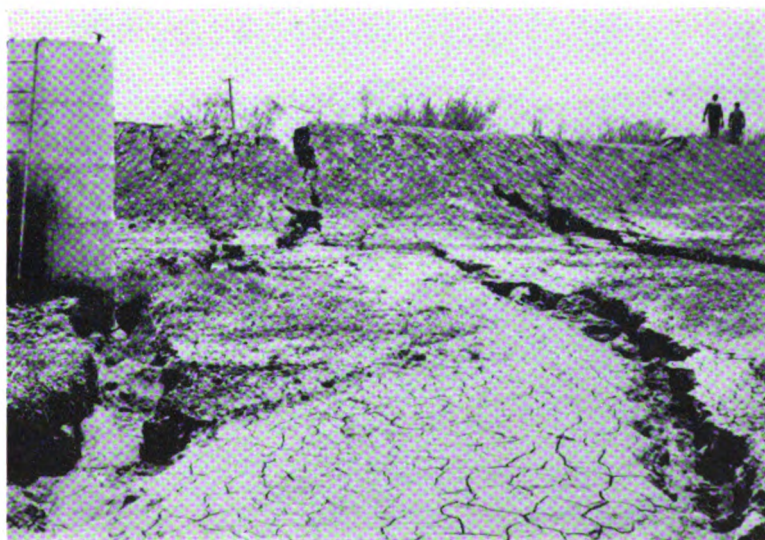
Photo No. 2—Northwest trending cracks near a reservoir about 15 miles south of Bakersfield. Cracks have been widened by water pouring from the reservoir.

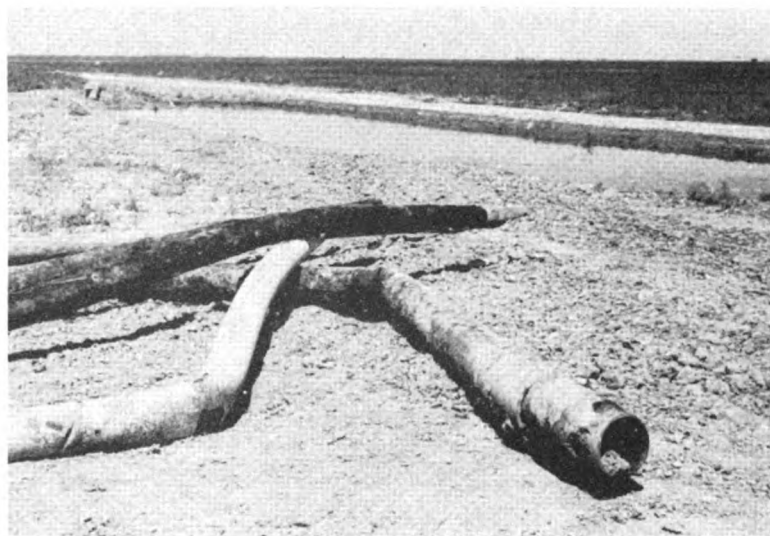
**Pipelines—Oil.** Steel pipelines used in conveying petroleum were severed by landslides caused by the earthquake in the vicinity of Grapevine near Highway 99. Lateral displacement of alluvium in the area north of Highway 166 caused breaks in other oil lines. Several breaks occurred near the location of photos 1, 2, and 3 on Plate B. Rupture of lines appeared to take place at points of weakness, as all breaks do not necessarily appear to have occurred in areas of particularly sharp movement. A cumulative compression or stretching effect caused ruptures especially where the lines curved. These steel lines averaged five-sixteenths inch thick and ranged in diameter from 6 to 10 inches. The line to one General Petroleum pumping station, located about seven miles west of Highway 99 on Highway 166, bends gently to the north approximately  $1\frac{1}{2}$  miles north of the station. The pipe at the bend was separated 18 inches. One-half mile to the north, a four-foot section of an oil line curving gently to the west was first buckled sharply to the west then straightened out before breaking six feet further north. In the same vicinity, two pipes on opposite sides of a road striking north-south suffered the opposite kind of action. The line on the east side telescoped approximately 36 inches, while that on the west side pulled apart approximately 55 inches. These lines were about 30 feet apart at points of rupture. (See photo 3.)

Photo No. 3—Replaced oil line pipes about 15 miles south of Bakersfield which have been bent, twisted, telescoped up to 36 inches and separated up to 55 inches. Pipes are constructed of five-sixteenth inch steel and range from six to 12 inches in diameter. Lines are generally placed from two to three feet below the ground surface.

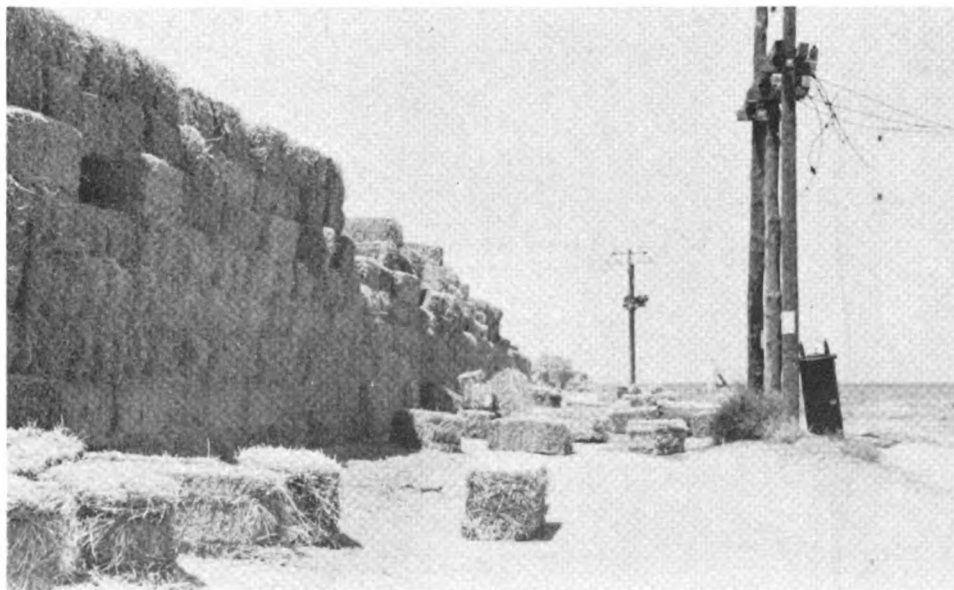
Many stacks of baled hay averaging 20 to 25 feet in height were badly shaken and toppled along the southwest-trending zone. Observations indicated that haystacks elongated in an east-west line were more severely affected than those stacked in a north-south direction. In either case, it was generally noted that most haystacks had fallen south and west.

Photo No. 4—Haystacks and transformers toppled about 15 miles south of Bakersfield along U. S. Highway 99.

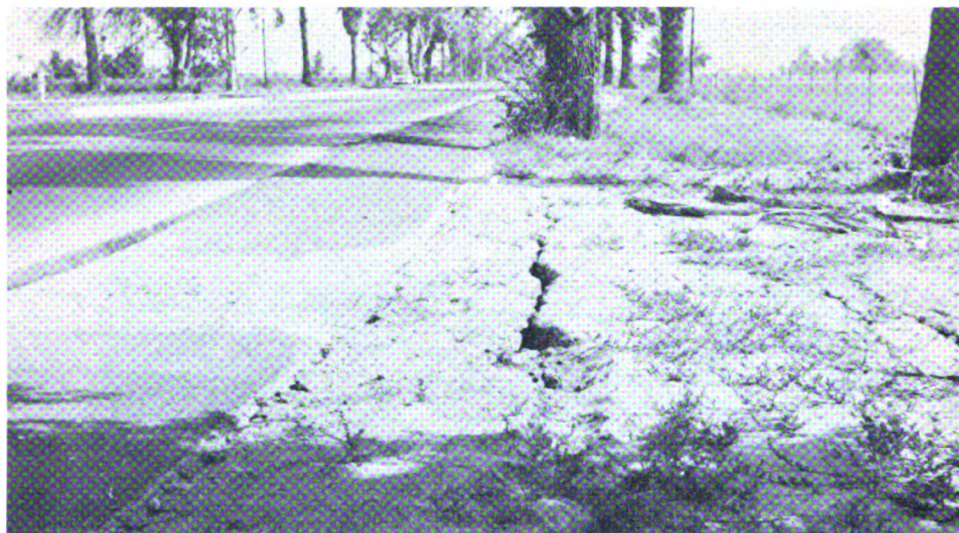
The northbound lane of Highway 99 suffered minor slumping about 10 miles south of Bakersfield. (See photo 5.) Differential settling caused large cracks on the shoulder up to about three inches in width and about a five-inch vertical drop between the concrete road surface and the asphalt shoulder. (See photo 5.) Cracks and settling also were noted in the field to the east of this road slump. This area was marshy prior to construction of the highway. The highway fill was imported as select material. Increased consolidation at depth of the boggy material and/or fill probably resulted in the slumping brought about by the earth movement.

Photo No. 5—U. S. Highway 99 about 10 miles south of Bakersfield. The concrete paved roadway sagged but did not fracture. Photo by Division of Highways.

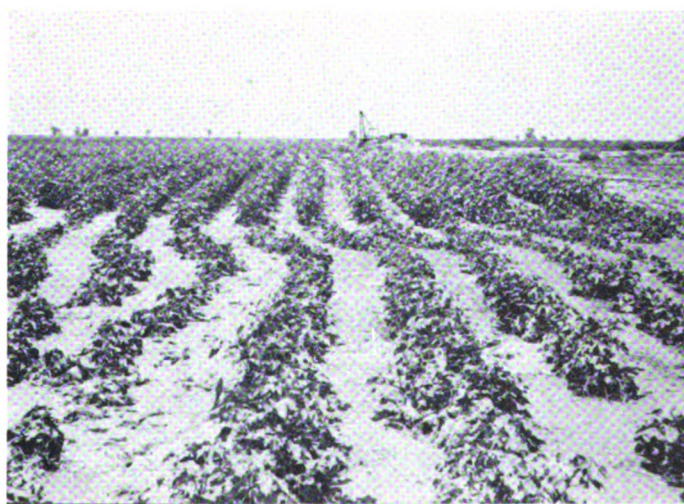
Offset cotton rows were observed at numerous points within the general northeast-trending zone. At one such point, located in T. 32 S., R. 28 E., M. D. B. & M., about 17 miles south of Bakersfield and about one-half mile east of Highway 99, cotton rows were offset on the order of three feet. (See photo 6.) Approximately three miles airline southwest of Arvin both north-south and east-west cotton rows were offset. Rows trending north and south showed movement to the west on the south side of the offset. East-west trending rows showed movement to the south on the west side of the offset. An east-west road in the vicinity of this location was offset in a northeast direction at least five feet.

Photo No. 6—Offset cotton rows about 17 miles south of Bakersfield and one-half mile east of U. S. Highway 99.

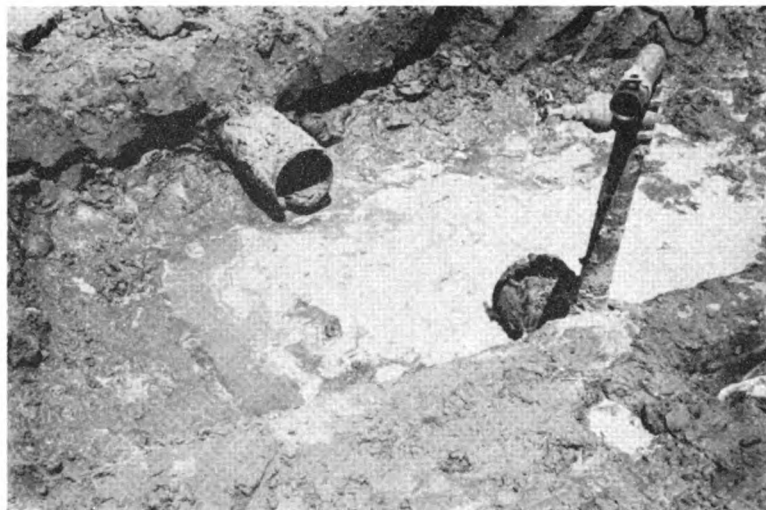
**Photo No. 7—Facing north, steel water line pipe separated about 17 miles south of Bakersfield, and one-half mile east of U. S. Highway 99.**

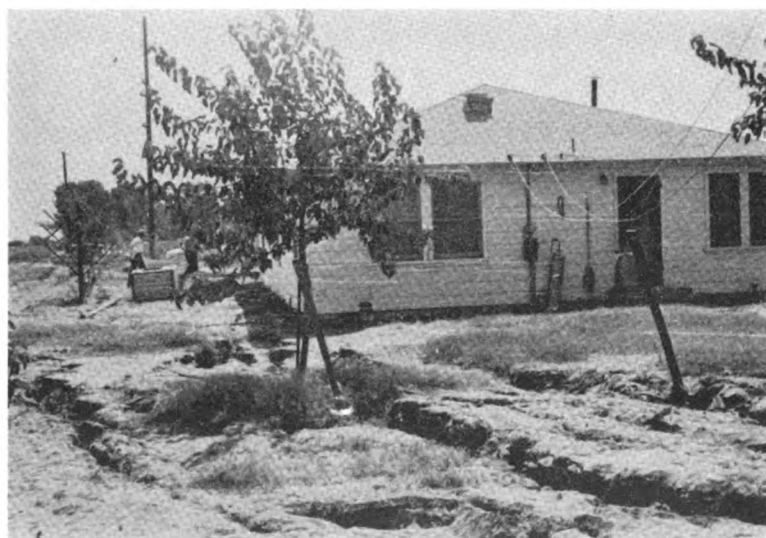
In general, buildings resting on relatively unconsolidated alluvial deposits suffered more heavily in the megaseismic area than those constructed on firmer terrain. Although most frame buildings incurred only slight damage, some were shaken from their foundations in the zone of strong surface effects. (See photos 8 and 9.)

**Photo No. 8—Cracking of ground about three miles southwest of Arvin. Cracks turn and go under house, and though chimney fell and house was slightly damaged it still stands.**  
*Photo by Division of Architecture.*

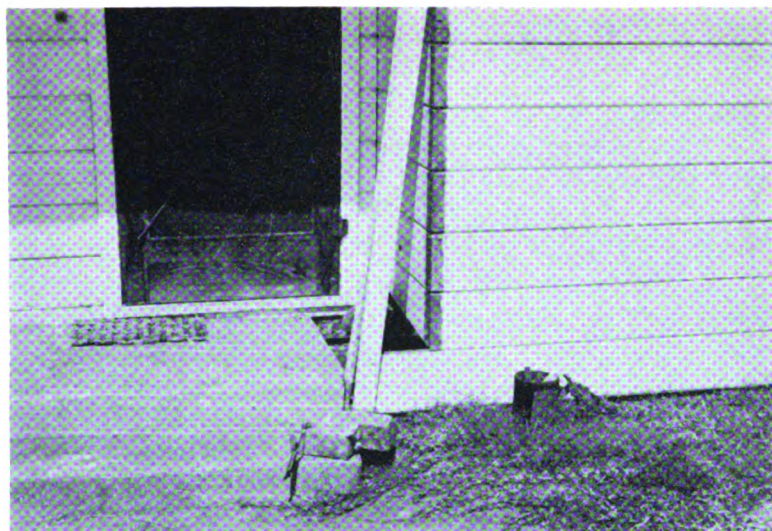
**Photo No. 9—Same house as in Photo No. 8. House shifted one foot on its foundation.  
Photo by Division of Architecture**

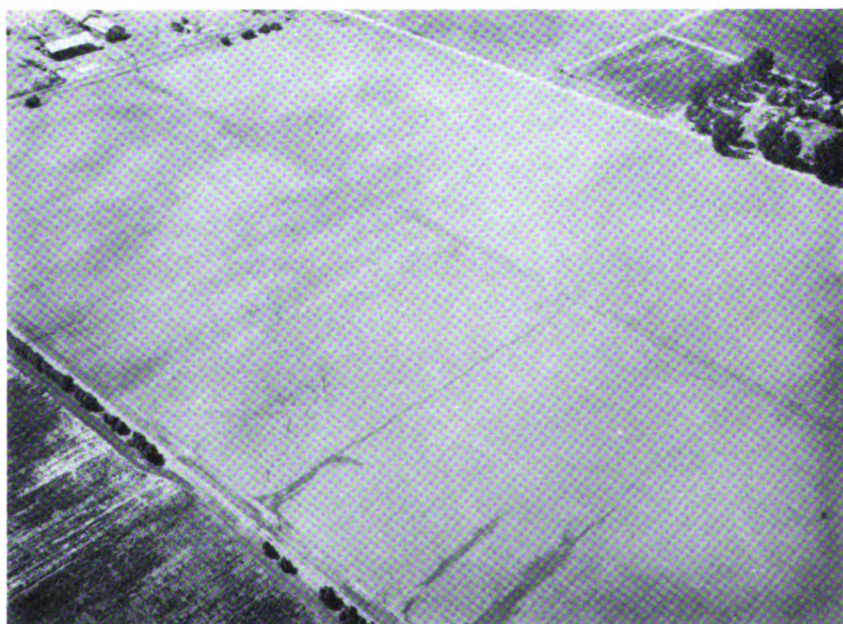
**Photo No. 10—Cracking pattern in a plowed field about three miles southwest of Arvin. Swirl effect probably due to differential settlement of the sediments.**

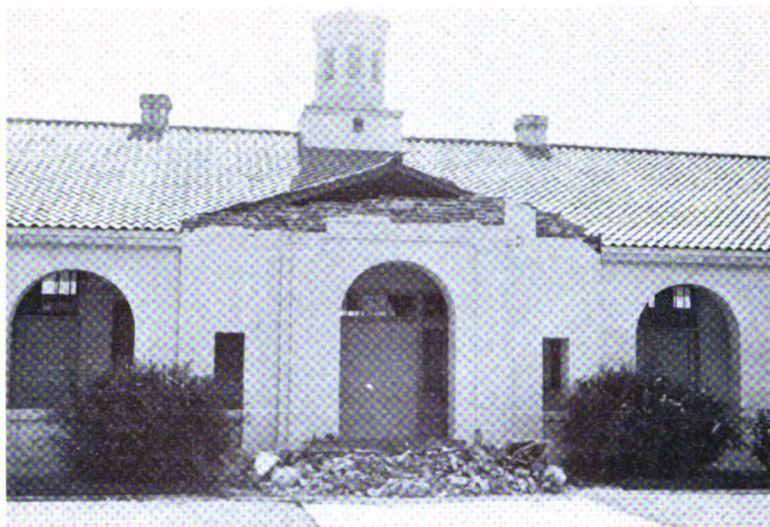
**Photo No. 11—This school located about five miles west of Arvin was in the megaseismic area. Two stone ornaments insecurely fastened on either side of archway rocked loose and pulled out a few bricks. Balance of school undamaged.**

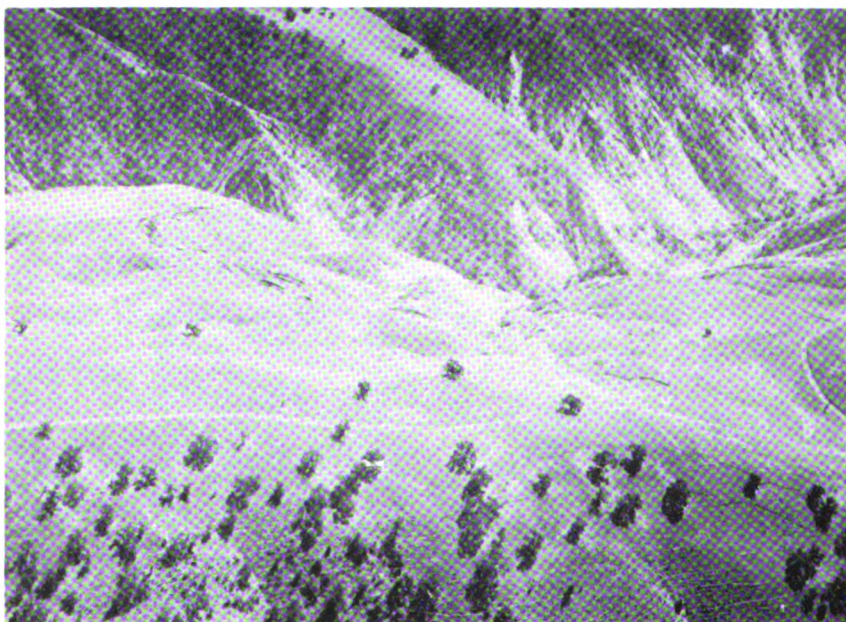
**Photo No. 12—Huge old slide in Sycamore canyon in foreground and recent minor slides on spurs. Note incipient slide near hilltop in the foreground.**

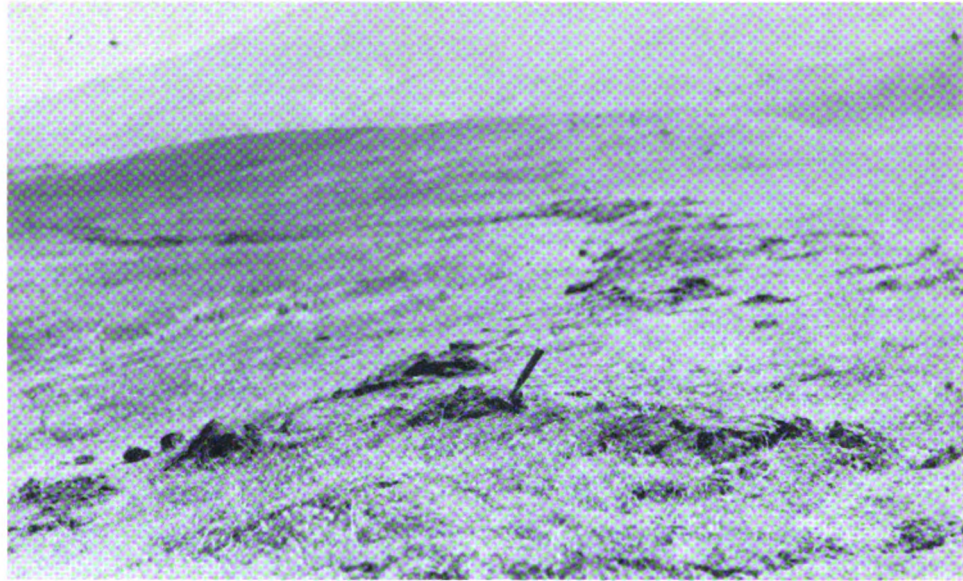
Northeast of the mouth of Comanche Creek and approximately six miles east of Arvin along the road to Highway 466, a narrow, scarp-like feature was extremely prominent. (See photo 13.) This feature could be easily traced along portions of the northwest flank of Bear Mountain. Vertical displacement on the gently sloping surface approached a maximum of three feet, the southeast side of the surface break being consistently upthrown. Thrusting of the southeast side over the northwest side was observed at some points with up to 40 inches of foreshortening. This break was fairly consistent but was occasionally lost for short sections. In the area immediately southwest of Highway 466, rifting trended approximately N. 50° E. Slump cracks were quite prominent from Sycamore Canyon to Highway 466. Large-scale sliding was observed in the steep-walled Sycamore Canyon and to a lesser degree in smaller canyons nearby. (See photo 12.)

**Photo No. 13—Zone of fracturing in vicinity of the White Wolf fault about six miles east of Arvin. Breakage indicates that the southeast side had been uplifted and thrust to the northwest.**

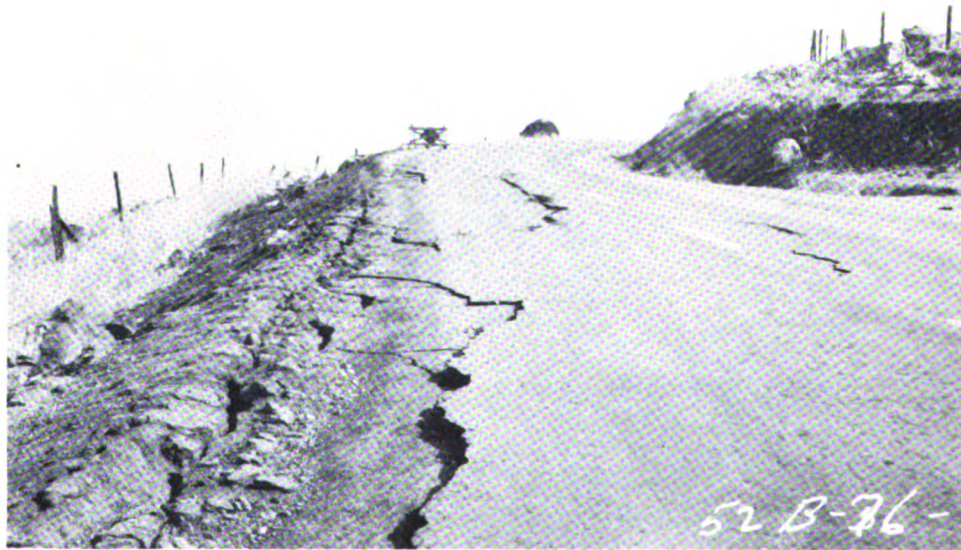
The paved highway from Arvin northeast to Highway 466 suffered damage due chiefly to slumping, along the outer edge of the fills. (See photo 14.) Numerous small earth slides from the poorly consolidated bank material also obstructed the road. Large rocks, loosened by the earth movement, rolled down from hillsides onto the roadway and caused minor damage to the pavement.

**Photo No. 14—Road cracking and slumping on the Arvin-Tehachapi road. Photo by Division of Highways.**

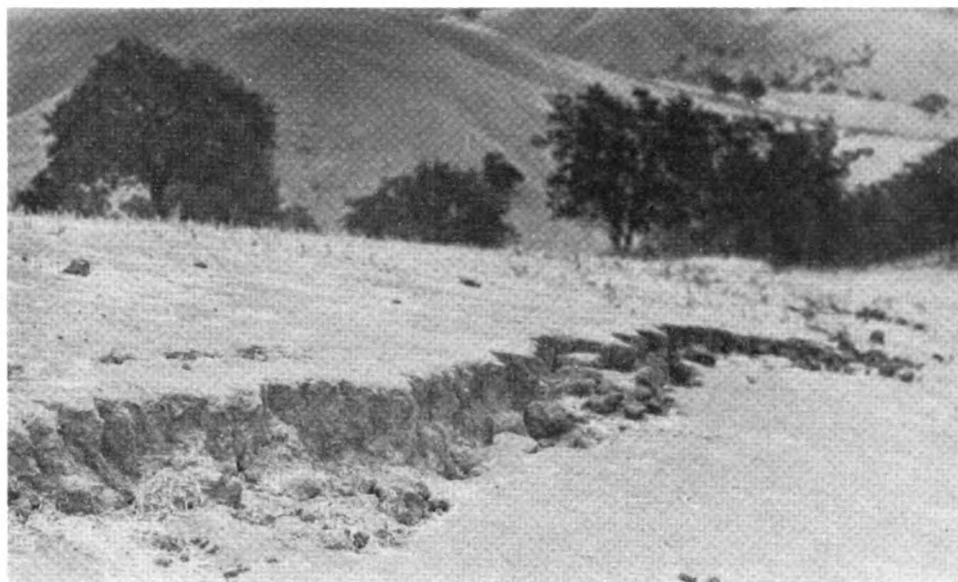
Near the Bealville turnoff the zone of cracking was about three-tenths of a mile wide. Vertical offsets up to one foot were present in this area but most of these could be attributed to slump. (See photo 15.) The general pattern of cracking indicated that the main movement in this area was the southeast side moving up and to the northeast, each component of movement being only a few inches.

Photo No. 15—Offset of ground surface north of U. S. Highway 466 near the Bealville turnoff. Offset is one foot with the northwest side up. Much of this movement is probably due to slump.

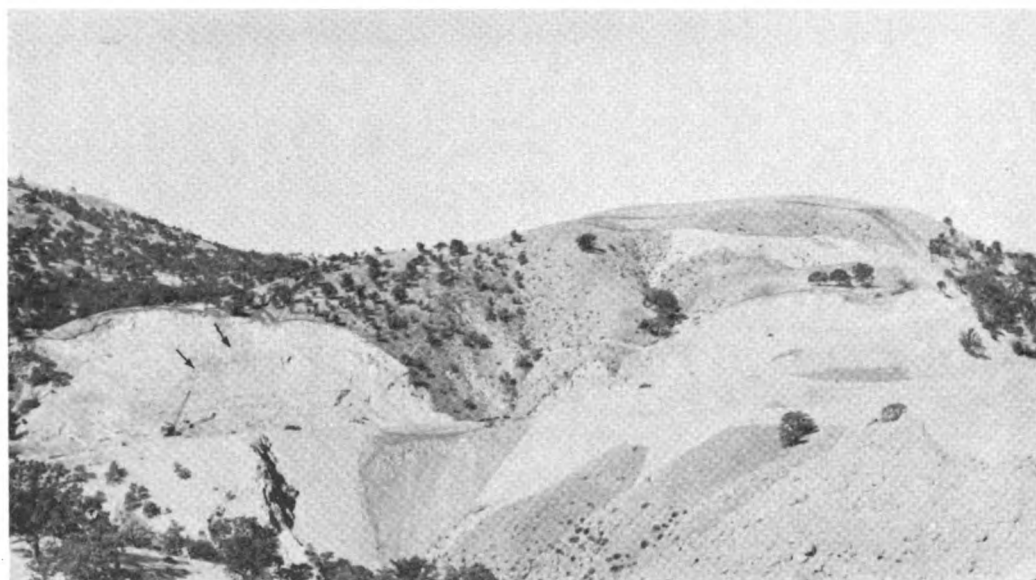
Photo No. 16—View looking southwest toward former location of Southern Pacific Tunnel 4 on left and Tunnel 3 on right located south of Caliente. Note dark zone dipping 43 degrees to east in cut above Tunnel 4. This zone is a fault breccia with gouge matrix. Some movement probably took place along this zone for Tunnel 4 was damaged severely where this zone intersected the bore.

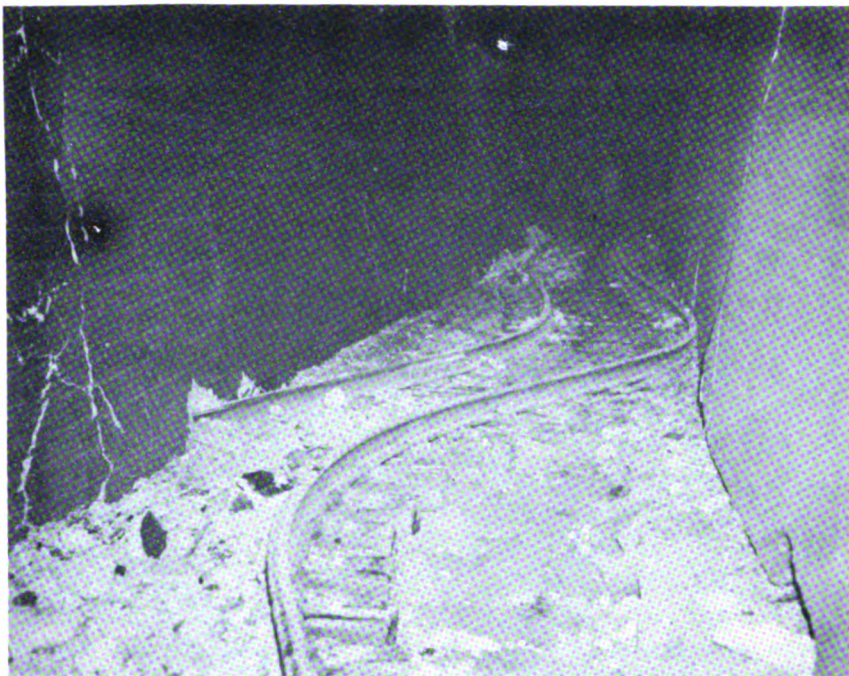
**Photo No. 17—Rails and walls buckled by compression in Southern Pacific Tunnel 3 about one mile south of Caliente. Photo by Southern Pacific Company.**

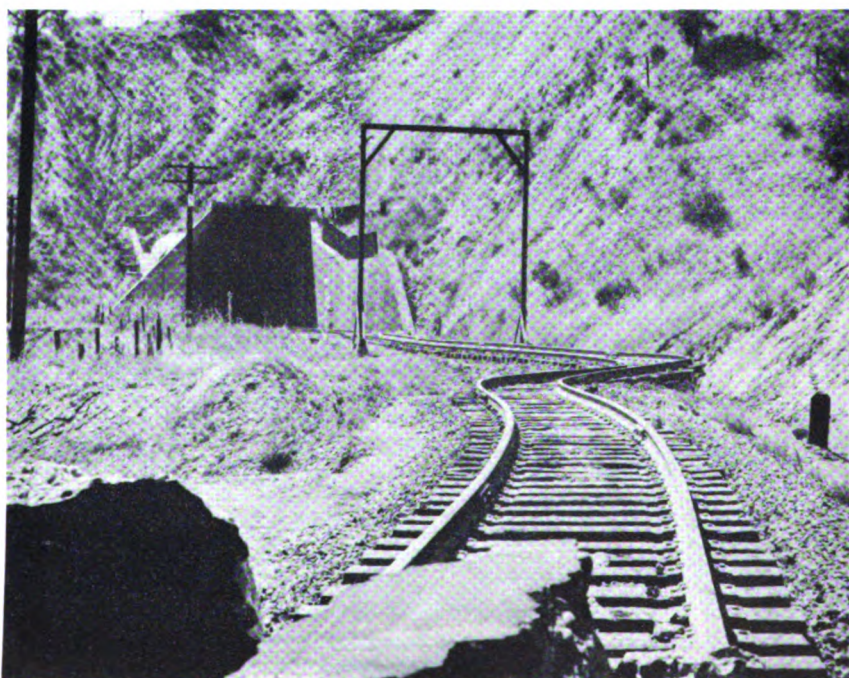
**Photo No. 18—Rails twisted by compression between Southern Pacific Tunnels 3 and 4 about one mile south of Caliente. Photo by Southern Pacific Company.**

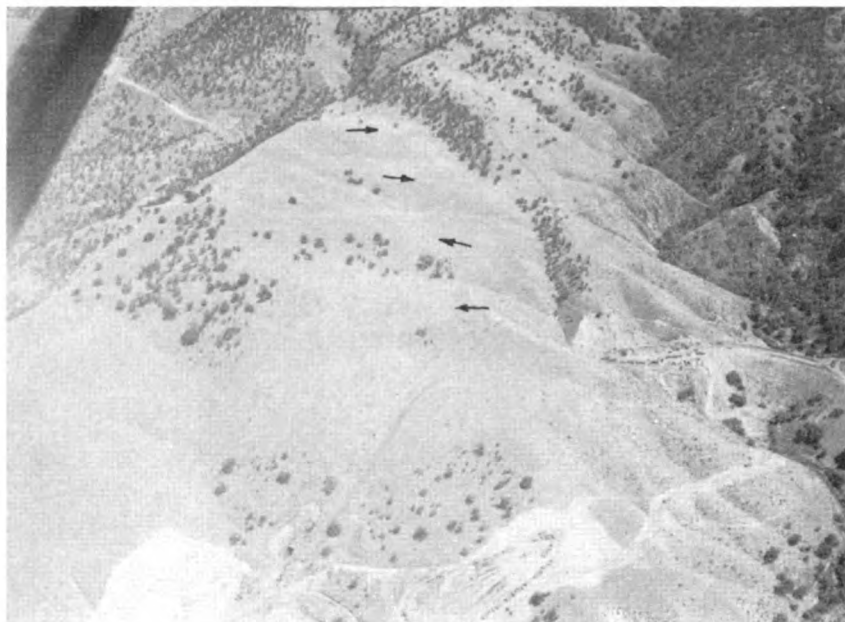
Photo No. 19—Cracking on hillside over Southern Pacific Tunnel 5 south of Caliente. Prominent northwest trending crack, probably representing cross faulting at right angles to the main trend of the White Wolf fault, extends for approximately 3,000 feet. Construction work in picture shows beginning of cut for a temporary shoofly around Tunnel 5.

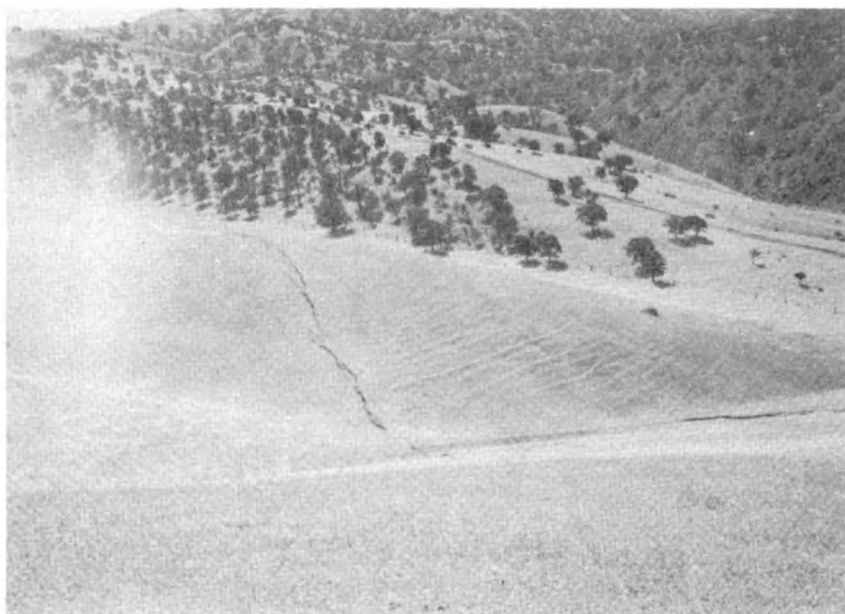
Photo No. 20—A northwest trending rift which began over Southern Pacific Tunnel 5 south of Caliente. This rift could be traced for about 3,000 feet and possibly represents a cross fault to the main northeast trending White Wolf fault. Nature of the cracking indicates that the northeast side of the rift has been dropped and that the plane of slippage dips approximately 45 degrees to the northeast.

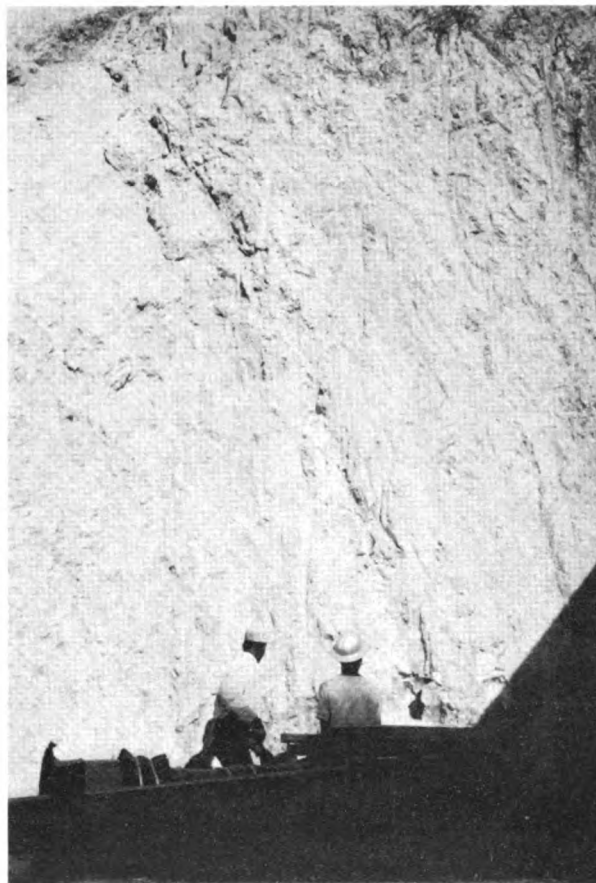
**Photo No. 21—A fault exposed 21 feet north of the north portal of Southern Pacific Tunnel 5 south of Caliente. The dark zone to the right of the break is a dense gray gouge up to 14 inches thick. The fault strikes N. 70° W. and dips 22° N. at the surface steepening to 70 degrees at the base of the cut. No recent movement was apparent along this fault.**

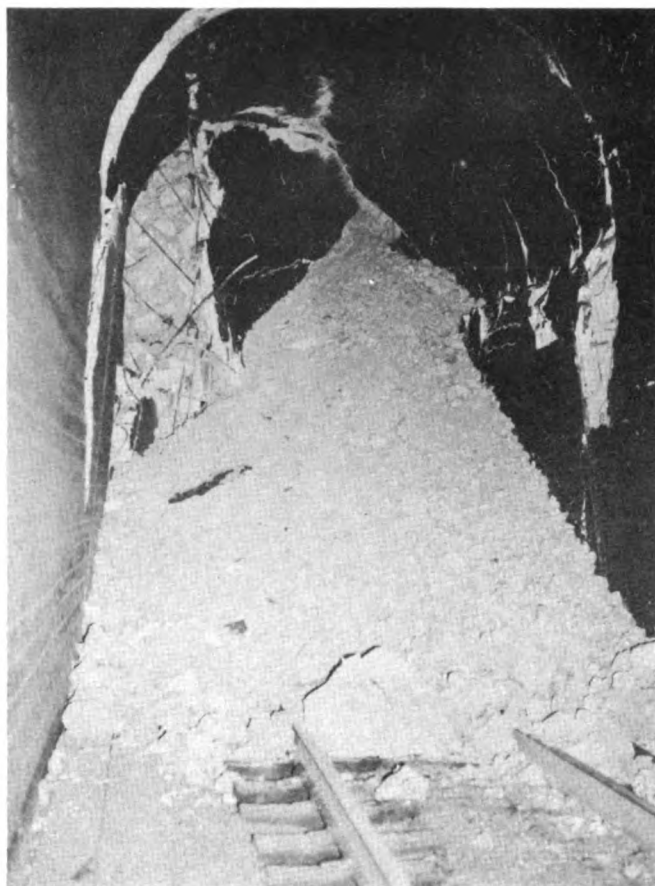
**Photo No. 22—Cave-in in Southern Pacific Tunnel 5 about one mile south of Caliente. Photo by Southern Pacific Company.**

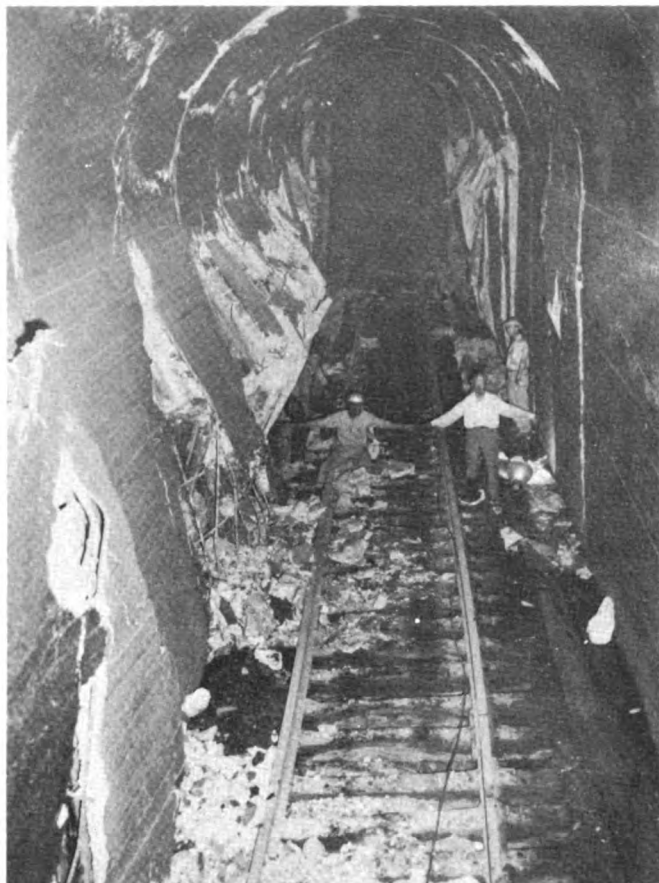
**Photo No. 23—Facing south in Southern Pacific Tunnel 5. Compression of east wall toward west. Photo by Southern Pacific Company.**

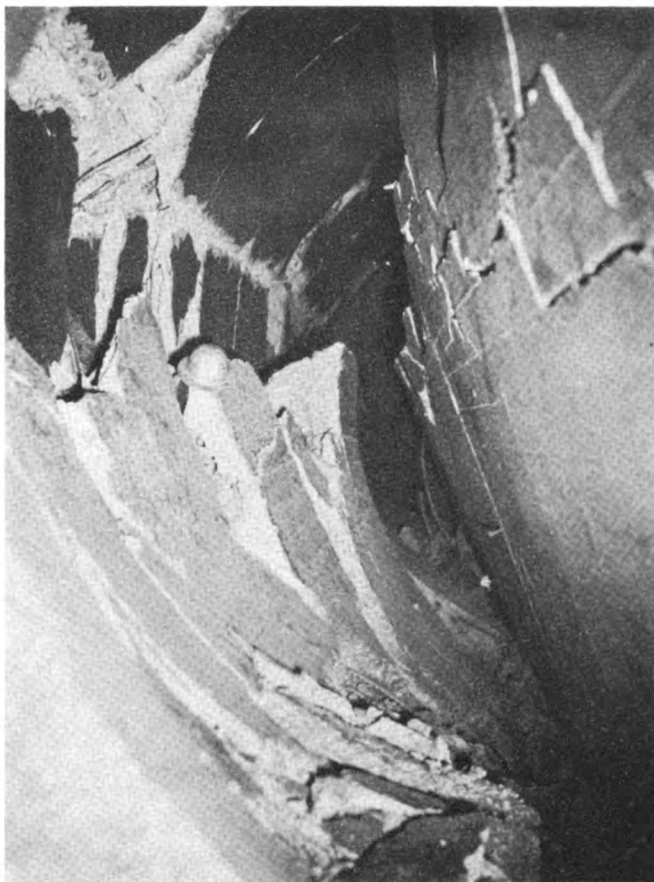
**Photo No. 24—Facing north in Southern Pacific Tunnel 5. Extreme movement by east wall toward west. Photo by Southern Pacific Company.**

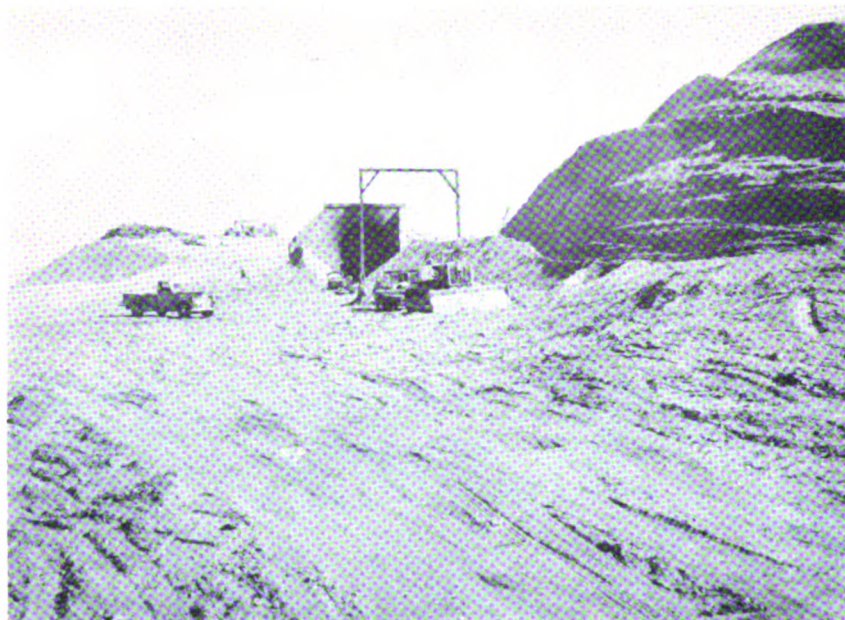
Photo No. 25—Southern Pacific Tunnel 6 about one mile south of Caliente. Tunnel has been daylighted and since has been entirely removed.

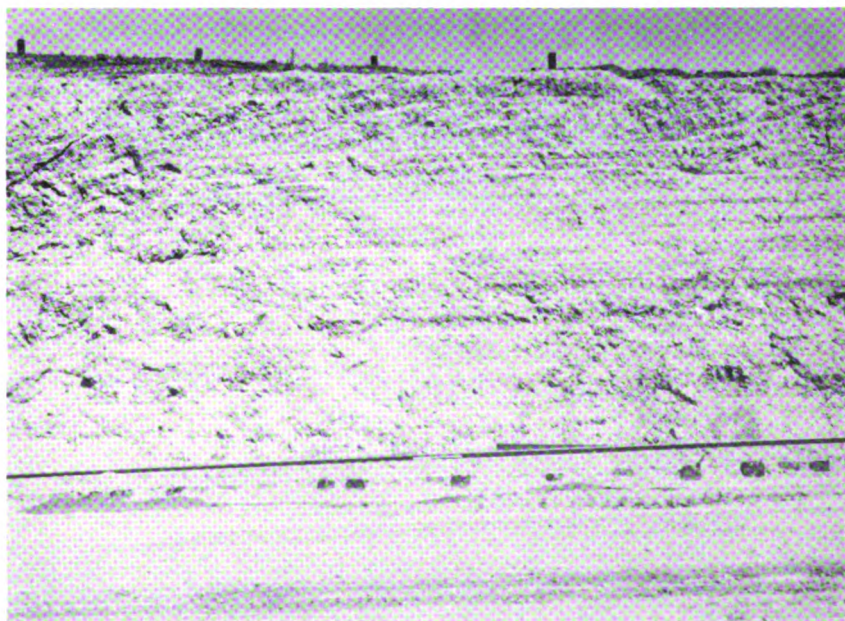
Photo No. 26—Fault zone about 500 feet upgrade from Southern Pacific Tunnel 6 south of Caliente. Some of the cracks that can be seen in the cut can be traced on the surface.

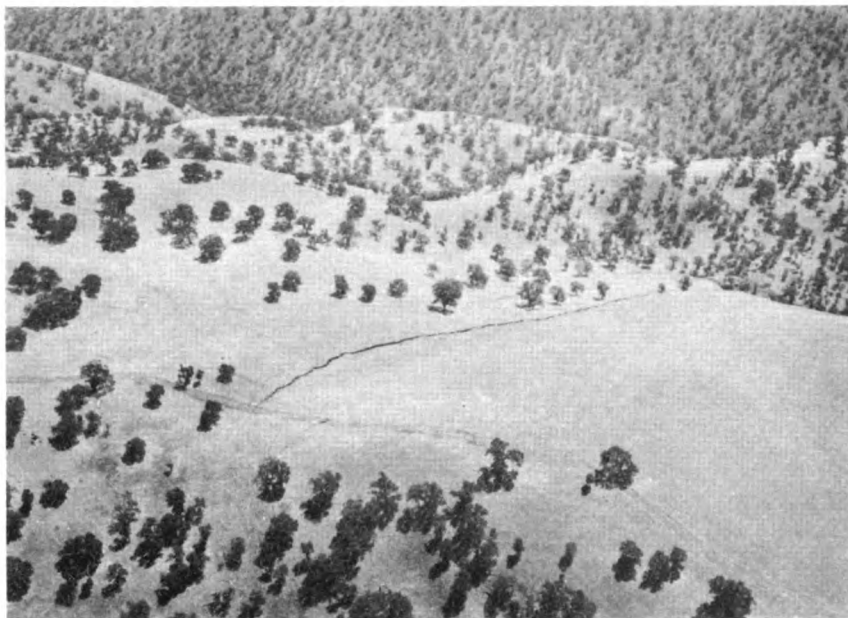
**Photo No. 27—Large surface crack extending over ridge top northeast of Bealville. This crack is near the northeast extent of surface breaks along the trace of the fault.**

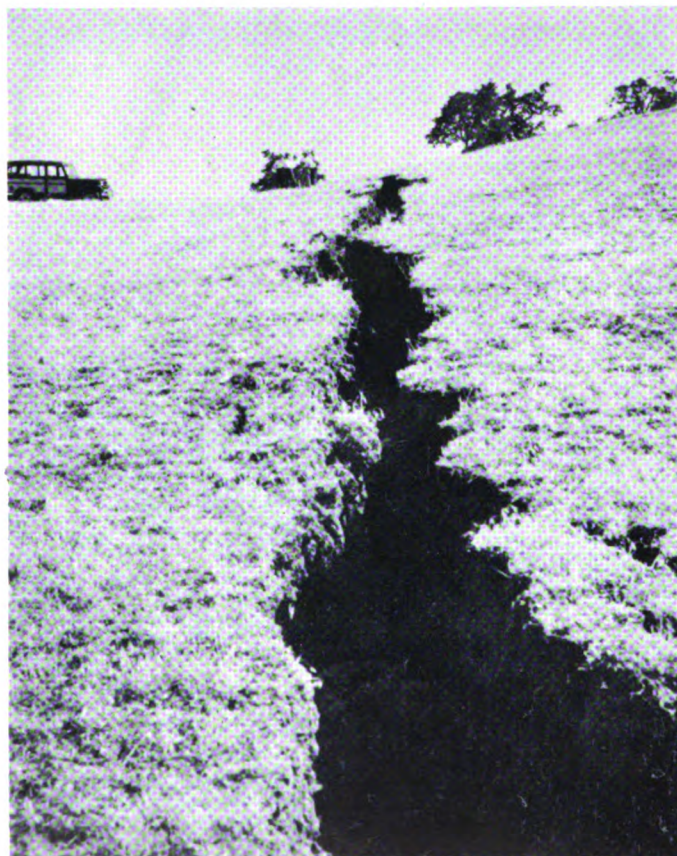
**Photo No. 28—Close-up of large surface crack on Photo No. 27. Largest surface expression noted in the area. Photo by Southern Pacific Company.**

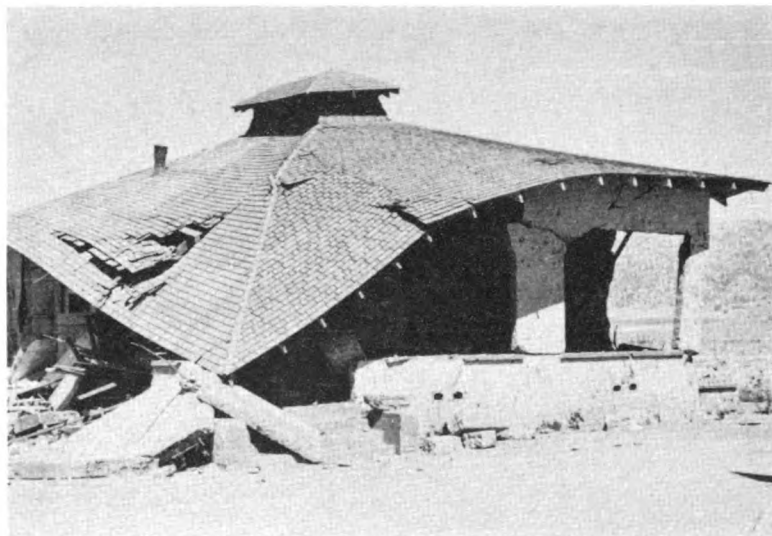
buildings which were apparently poorly constructed were severely damaged. Poor mortar and/or bond, lack of or inadequate reinforcing steel, lack of bond beams, and thin walls appear to be responsible for most of the damage. Well built frame buildings and reinforced concrete buildings fared much better. Modern buildings, particularly schools that were designed and built after passage of the Field Act, suffered only slight damage. (Contrast photos 29 with 32 and 30 with 31.)

**Photo No. 29—Cummings Valley School located nine miles southwest of Tehachapi in alluvial filled valley. This building, constructed prior to 1933 is allegedly built of reinforced concrete though reinforcing bars do not extend from columns into beams or foundation. Photo by Division of Architecture.**

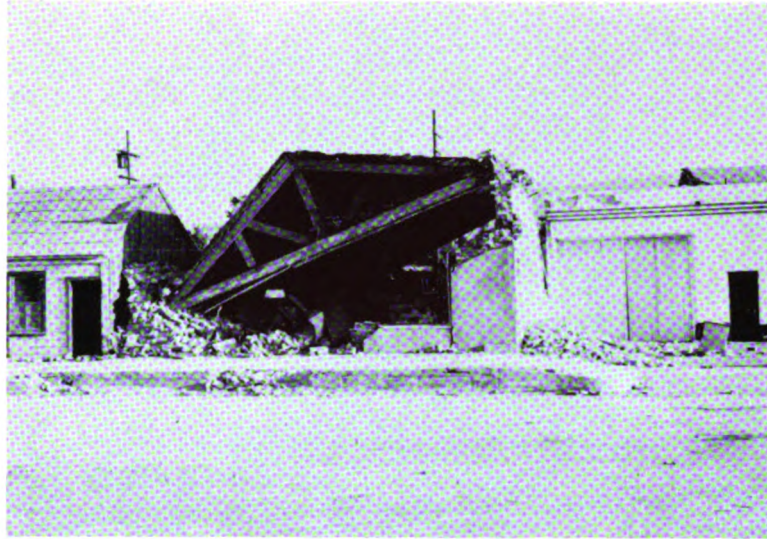
Photo No. 30—Main street of Tehachapi. Collapse of roof due to failure of brick and plaster walls. Poor bond and/or mortar may be responsible. *Photo by Division of Architecture.*

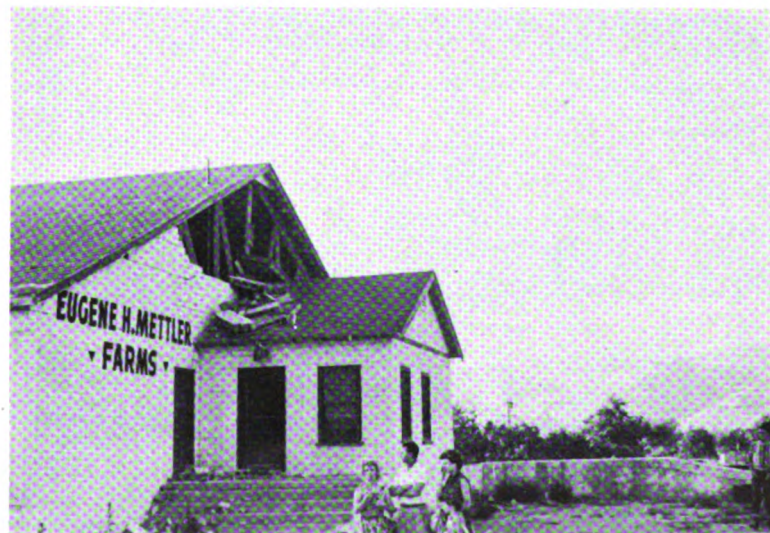
Photo No. 31—Brick building across street from previous photo showing good brick construction with bond beams. A few bricks fell as a result of racking of wooden truss roof. *Photo by Division of Architecture.*

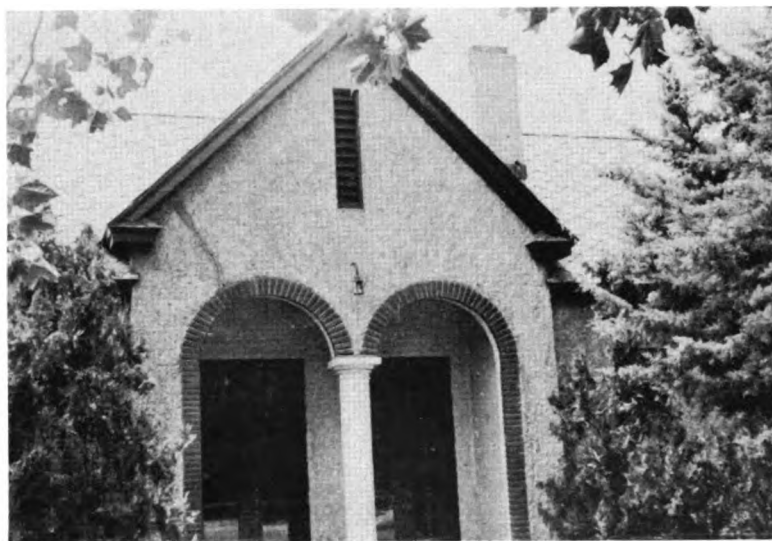
**Photo No. 32—Tehachapi school constructed more recently than Cummings Valley school. Though in a center of destruction, the only damage was reopening of a crack above an arch. The original crack was opened by a previous minor earth shock. Photo by Division of Architecture.**

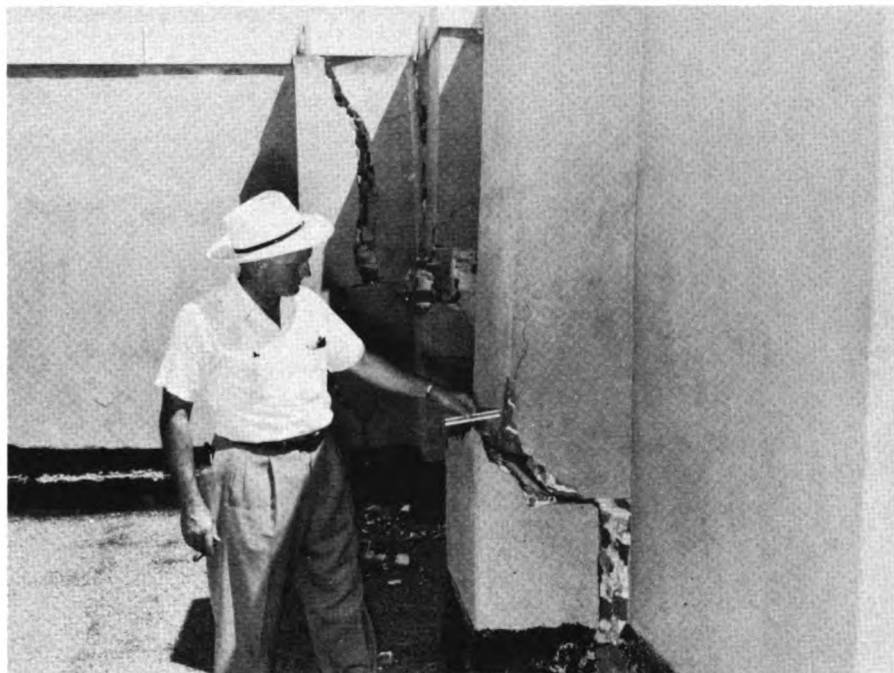
**Photo No. 33—Kern County Courthouse roof showing failure of northeast corner of nonreinforced parapet. Brick construction with plaster coat. Steel column extends only to the roof. Photo by *The Bakersfield Californian*.**

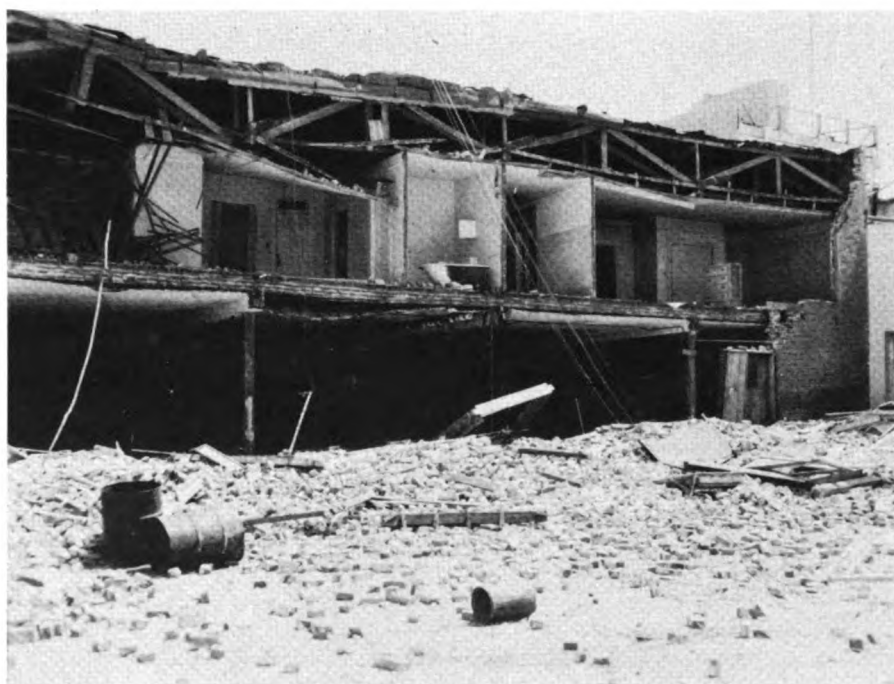
**Photo No. 34—Eye Street apartment in Bakersfield. Complete collapse of brick rear wall. Photo by *The Bakersfield Californian*.**

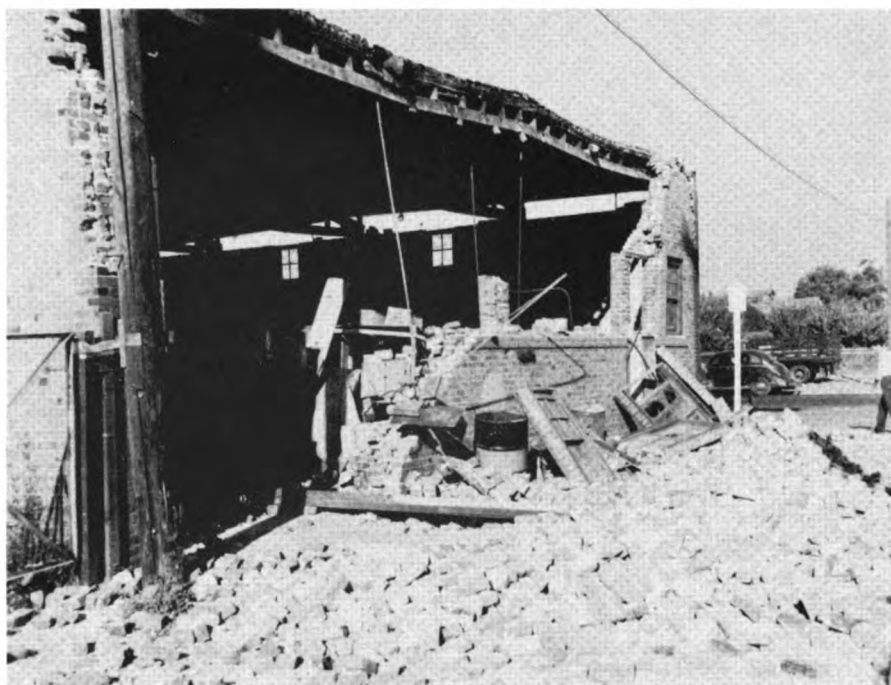
**Photo No. 35—Salvation Army storeroom in Bakersfield on Sumner and Kings Streets. Brick construction; windows and doorways add to instability of a nonreinforced wall. Photo by The Bakersfield Californian.**

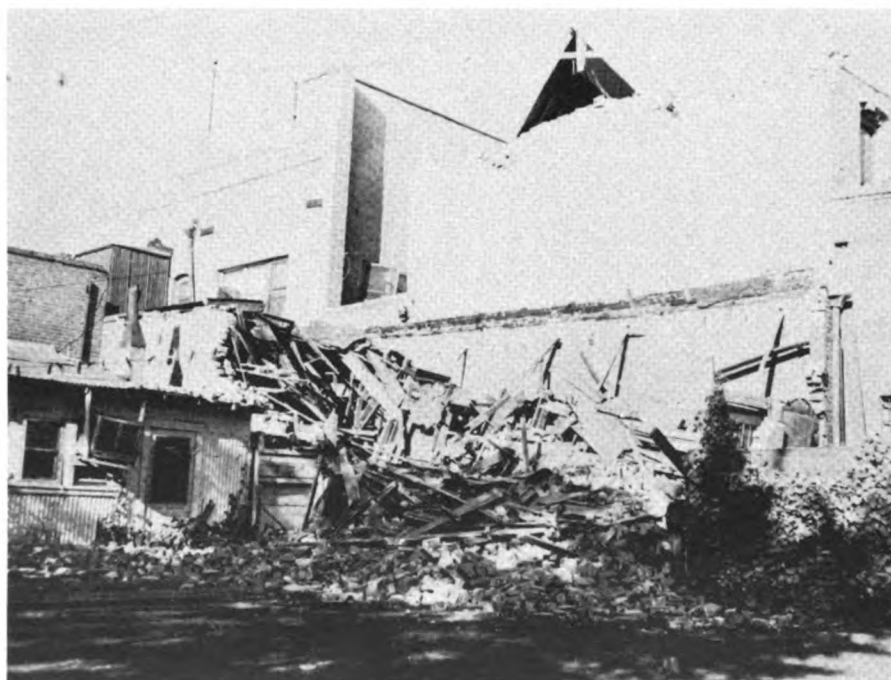
**Photo No. 36—Rear of building next door to Metropole Hotel on Sumner Street. Parapets damaged on hotel roof. Roof failure as nonreinforced brick wall moved outward during earthquake. Photo by The Bakersfield Californian.**

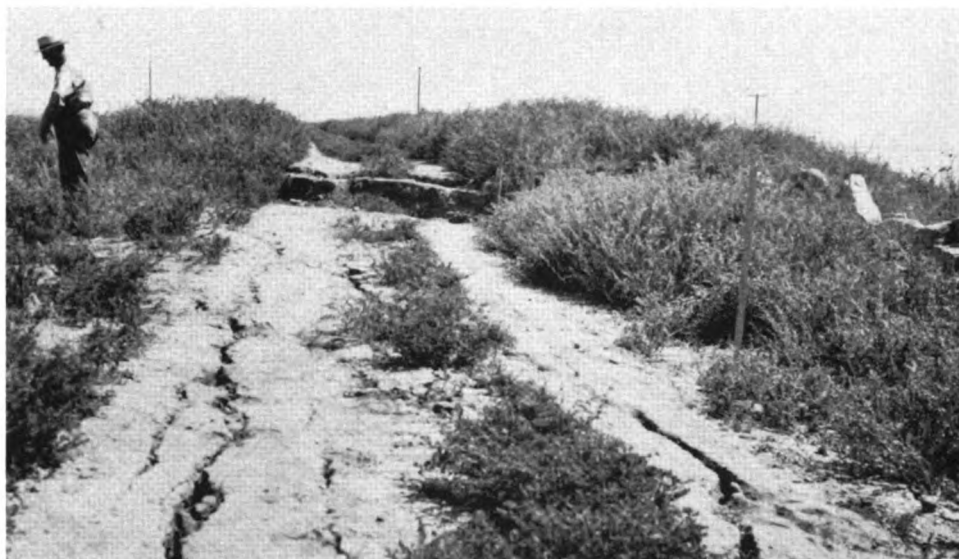
A portion of East Levee bounding part of Buena Vista Lake slumped vertically approximately two feet during the earthquake. It appears that solution cavities existing in soluble gypsiferous beds beneath may have allowed excessive settlement in this area. (See photos 37 and 38.) Severe damage to the Paloma oil field, farms, and residences in the area would have resulted had the lake levee been breached during the quake. Minor slumping was also noted along the railroad tracks which cross the southern portion of the levee. Slumping and fissuring were prominent along certain parts of the Kern Island Canal.

**Photo No. 37—Buena Vista Dam No. 732. East levee, looking south. Subsidence and cracking of fill caused by earthquake of July 21, 1952. Maximum settlement of two feet.**
