STATE OF CALIFORNIA  
DEPARTMENT OF PUBLIC WORKS  
DIVISION OF WATER RESOURCES

REPORT ON  
PHYSICAL EFFECTS OF  
ARVIN EARTHQUAKE  
OF JULY 21, 1952

August, 1952

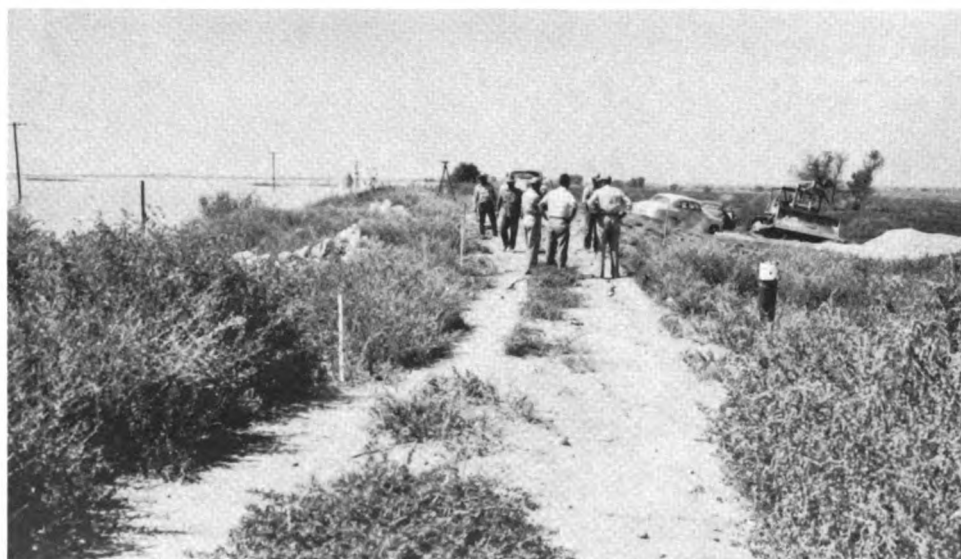
**Photo No. 38—Buena Vista Dam No. 732. East levee, looking north. Subsided section of fill. Dozer starting low levee construction using imported stockpiled materials.**
