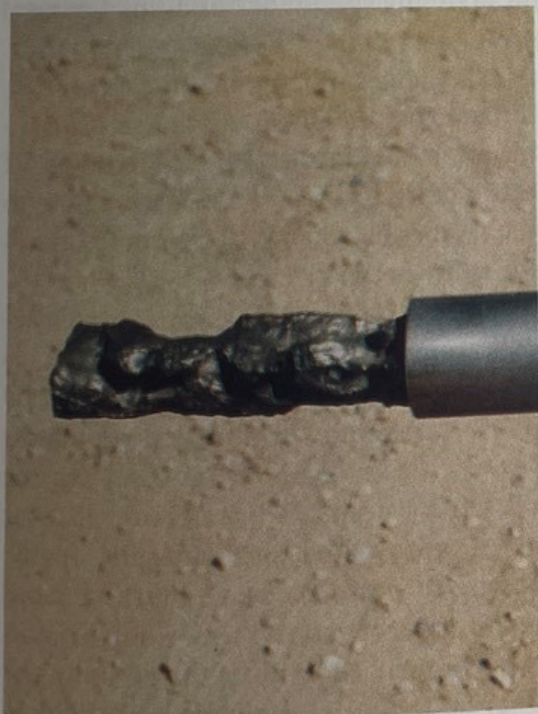
Figure 19.13. Destruction of this pump shaft has been caused by the creation of galvanic cells between the steel shaft and the bronze impeller. (Bergerson-Caswell Inc.)

Corrosion of pump surfaces by chemically aggressive groundwater accounts for many pump maintenance problems. For example, galvanic cells can be set up between steel shafts and bronze impellers, producing nonuniform corrosion (Figure 19.13). A zinc-free bronze alloy is more resistant to waters with high carbon dioxide concentrations and low pH; use of this alloy will lengthen the serviceable life of the impellers (Clark, 1980).
