STATE OF CALIFORNIA  
DEPARTMENT OF PUBLIC WORKS  
DIVISION OF WATER RESOURCES

REPORT ON  
PHYSICAL EFFECTS OF  
ARVIN EARTHQUAKE  
OF JULY 21, 1952

August, 1952

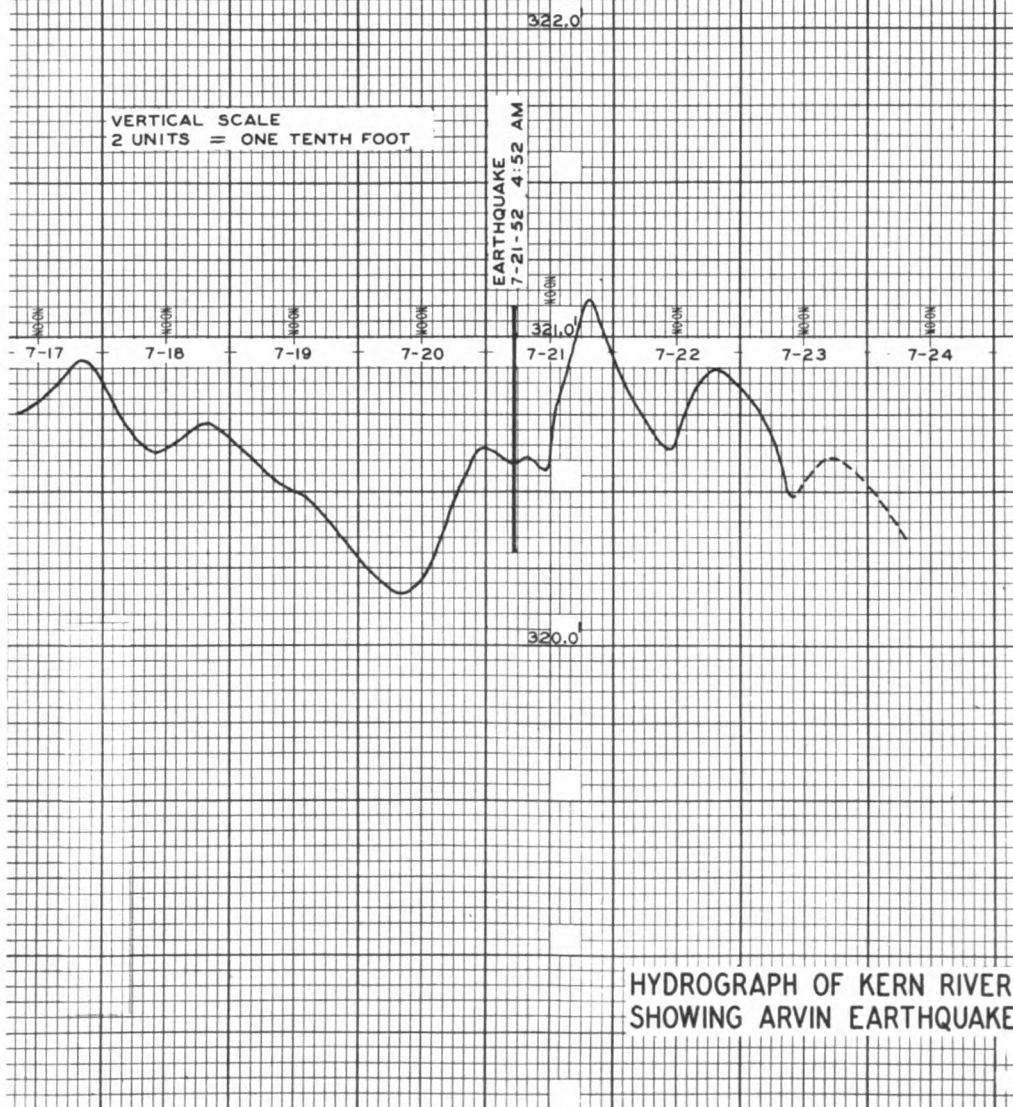
ONE MILE UP STREAM FROM ENOS

LANE  
SE COR. SEC. 13 T30S R25E  
M.D.B. & M.JULY 21, 1952 AT 4:52 AM  
ELEVATION OF WATER SURFACE 320.6 FT.  
MAXIMUM ELEVATION 321.1 FT.  
MINIMUM ELEVATION 320.3 FT.  
DIFFERENTIAL 0.8 FT.  
ELEVATION AFTER MAIN SHOCK 320.6 FT.VERTICAL SCALE  
2 UNITS = ONE TENTH FOOTEARTHQUAKE  
7-21-52 4:52 AM
